FAILURE ANALYSIS LAB
Isabella Panzica, Austin Reth, and Audrey Shultz
Department of Engineering and Physics
Elizabethtown College, Elizabethtown, PA

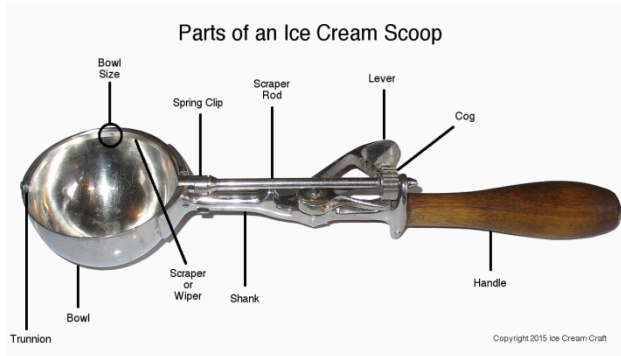
Figure 1: Diagram labeling the parts of an ice cream scooper similar to the type being analyzed. Taken from icecreamcraft.com

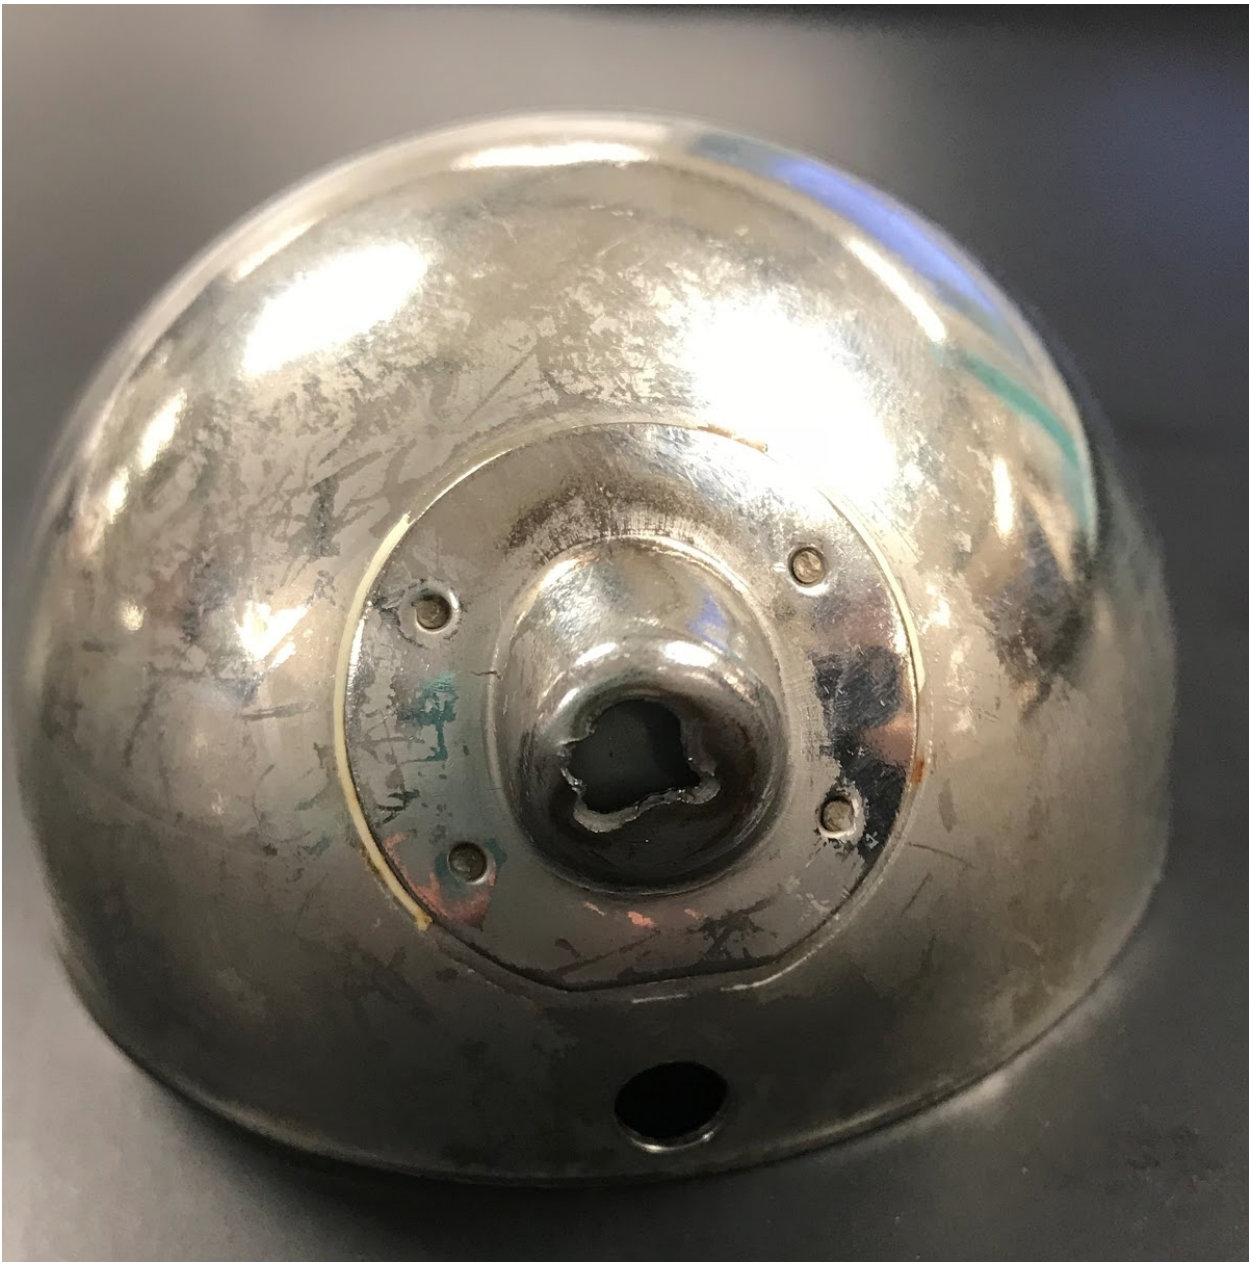
Figure 9: This is an image of the ice cream scoop's bowl that broke off of the handle.

In the images below, an up-close picture of the break is shown in Figures 3 & 7-11. It is evident from the microscope photos that there is previous cracking before the final break as there are signs of cracking at the breaking point of the weld. More than likely, this resulted from too much force being applied to the scoop consistently. The break was brittle because the scoop is made of stainless steel. If you look closely, you can see where the weld disconnected from the handle and scoop which caused the breaking. Overall, the break was clean, and there would be no noticeable chips of metal resulting in this failure.; the pieces of metal from the weld were microscopic and would not result in an injury to the mouth.

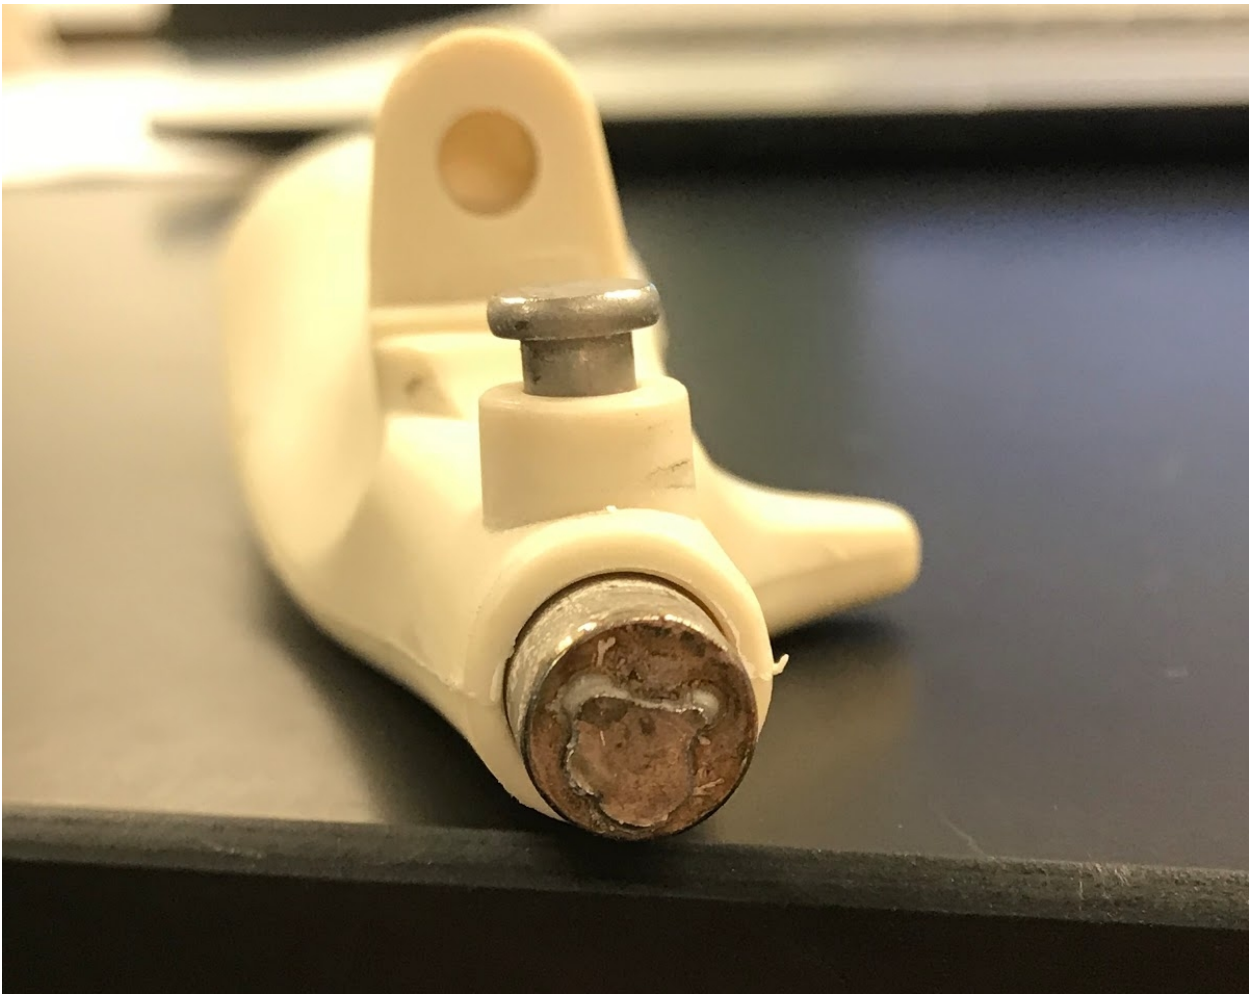
Figure 10: This picture is an image of the handle and shows the size of the weld relative to the size of the handle of the ice cream scoop.

simplest solution would be to train the staff to not engage the scraper until after the ice cream has been scooped. This would prevent the scraper rod from popping out of place in the first place. Another solution would be to use a larger weld to hold the two pieces of the shank together. A larger weld surface would decrease the overall all stress and increase the life of the ice cream scoop. Eliminating the weld entirely and making the shank one solid piece would be the most effective way to keep the ice cream scoop from failing there.

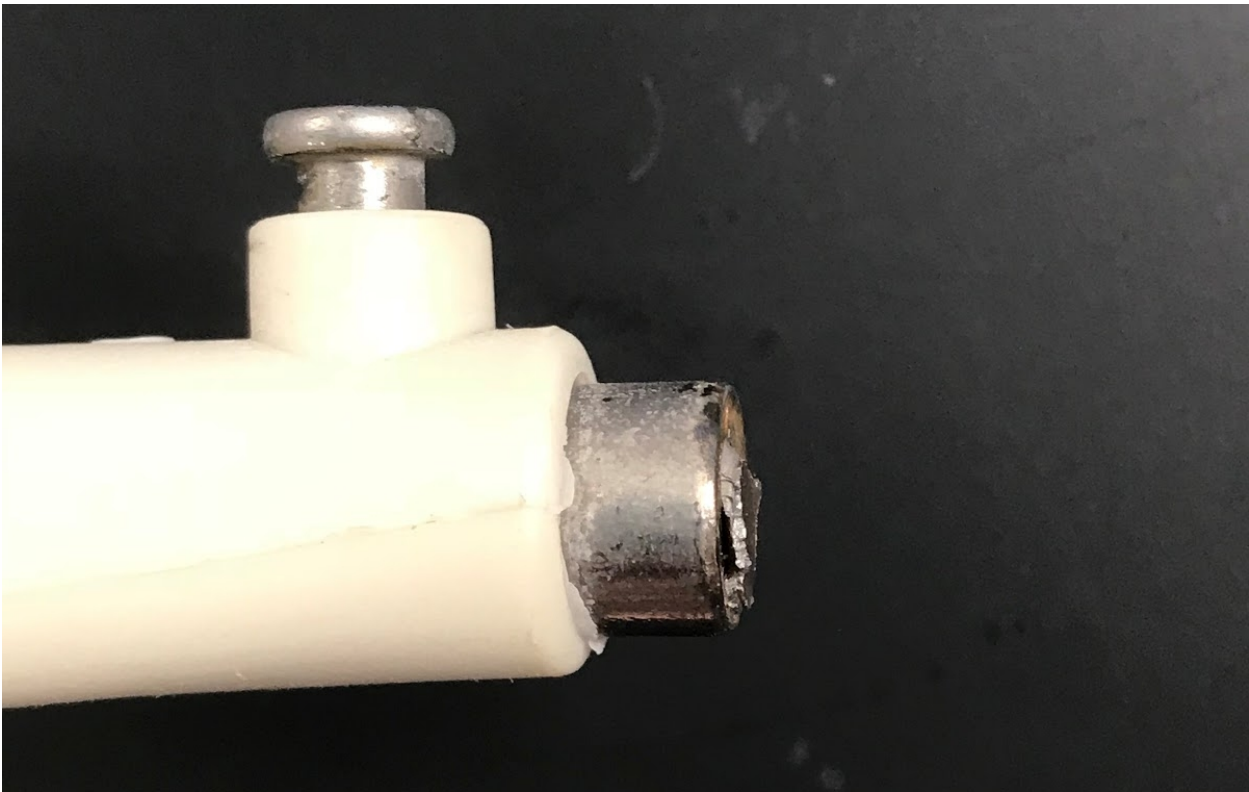
Figure 11: This is a side profile image of the weld that connected the bowl to the handle of the ice cream scoop.
